St.Michael & All Angels Church, Great Edstone

Update on repairs /July 2025

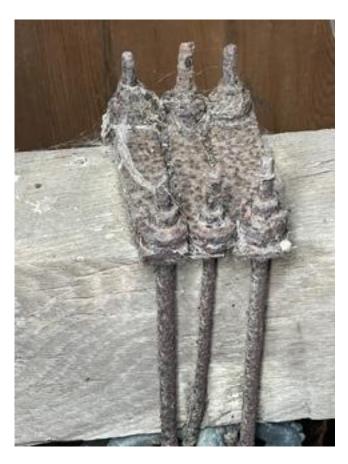
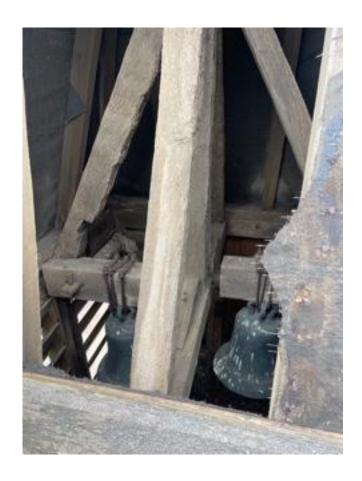
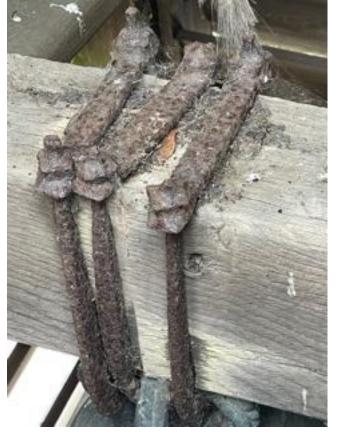
The bells and bell frame. The pictures attached tell the story. The basic structure of the frame is in oak and appears sound. However, diagonal timber braces are decaying from the underside, thereby weakening support, and will be replaced in

oak .The two bells are each hung on three U shaped support hangers which are badly corroded. (The bell on the north side appears to have later hangers.) This will require

new hangers to be fabricated in stainless steel. In order to obtain a profile (good match), one of the newer hangers will be removed and used as a template.
